Manhole Inspection Summary

Manhole # S71C1_010MH

Insp Date: **2/11/08 12:03 PM**

Location Address: **6528 Central Ave.**

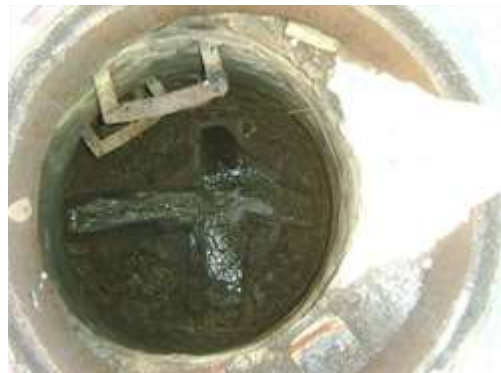
Top View

clogged outgoing 3 o'clock

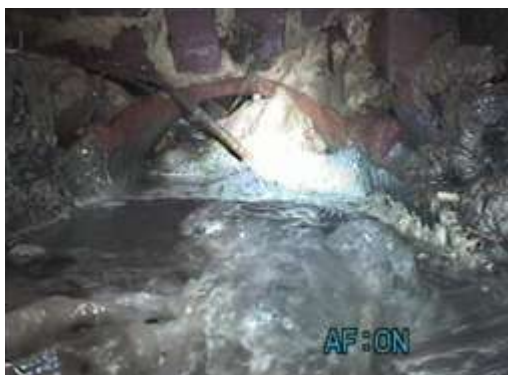
Defect 1

frame offset defect 5 in.

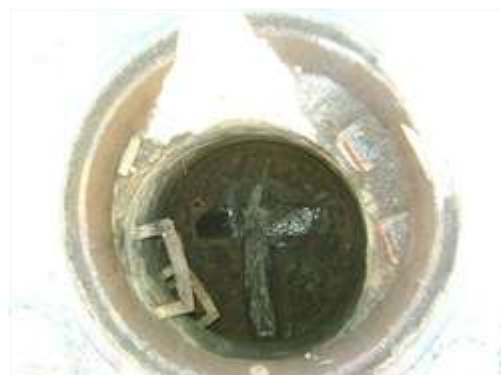
Defect 2

[dags] deposit attach grease in channel and pipes 3 to 9

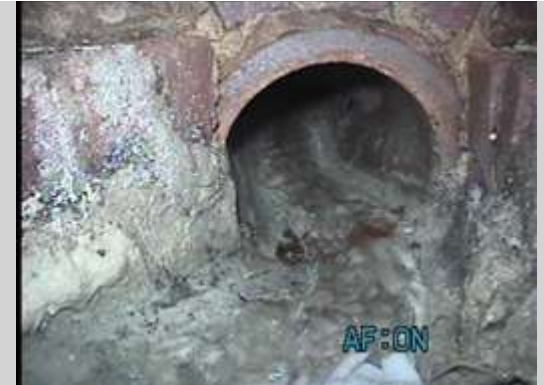
12 O'Clock Outflow

8 in. Circular Gravity Sewer
Pipe Out @ 12 O'Clock

Pipe Height: **8.4** (in.) Rod and Bar (Angled)
Pipe Material: **Clay** ☐ Pipe Lined
Invert Depth: **9.79** (ft.) Flow Characteristics: **Fast**
Deposits: ☐ None ☐ Mud ☐ Sludge ☐ Debris ☒ **Grease**
Silt Depth: **0.25** (in.) Deposits Extent: **Light**
Infiltration: **None** Pipe Seal Cond: **Sound**

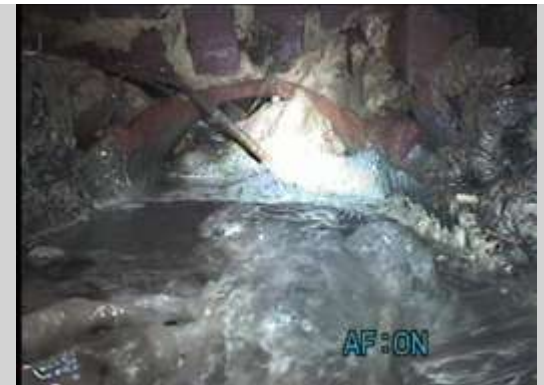
3 O'Clock Inflow

8 in. Circular Gravity Sewer
Pipe In @ 3 O'Clock

Pipe Height: **8.4** (in.) Rod and Bar (Angled)
Pipe Material: **Clay** ☐ Pipe Lined
Invert Depth: **9.71** (ft.) Flow Characteristics: **Slow**
Deposits: ☐ None ☐ Mud ☐ Sludge ☒ **Debris** ☐ **Grease**
Silt Depth: **5** (in.) Deposits Extent: **Heavy**
Infiltration: **None** Pipe Seal Cond: **Unknown**

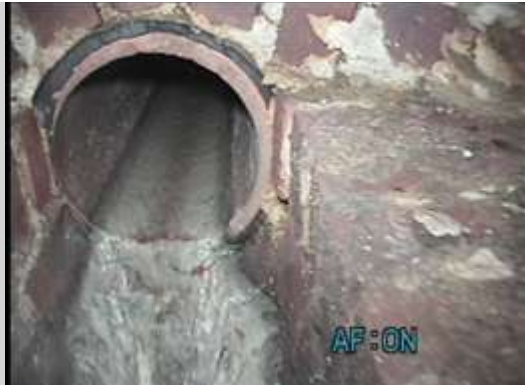
6 O'Clock Inflow

Deposits: ☐ None ☐ Mud ☐ Sludge ☐ Debris ☒ Grease

Silt Depth: **0.25** (in.) Deposits Extent: **Light**

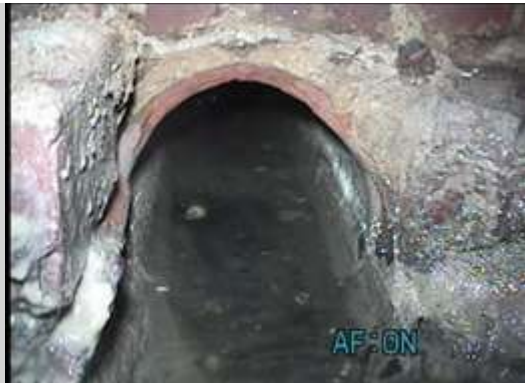
9 O'Clock Inflow

Deposits: ☐ None ☐ Mud ☒ Sludge ☐ Debris ☐ Grease

Silt Depth: **0.5** (in.) Deposits Extent: **Light**
